Customer Notification

B-CN-035-EN Rev A

SUBJECT: New Bearing and IGV Feedthroughs

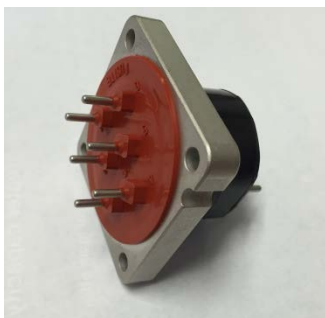
These new feedthroughs were **implemented to production** for all new DTC compressors and Spare Parts as of **March 31, 2016**. The new feedthroughs appear different having an orange colored rubber insulator on the front side as shown in Figure 1. The previous style had a black colored rubber insulator as shown in Figure 2.

Figure 1 - New Style Feedthrough
(6 Pin Feedthrough shown)

The **four and six pin Feedthroughs have been modified using a manufacturing process** which allows the rubber insulator to be over-molded onto the pins. This process will permanently affix the rubber insulator to the front side (the external side) as opposed to the process used previously which has the rubber insulator as a separate piece that can be lifted up and removed. There is no change to the type of material used.

This change was implemented as part of a product improvement to eliminate the possibility of any moisture, contamination, or other foreign debris from getting underneath the insulator and causing potential compressor damage.

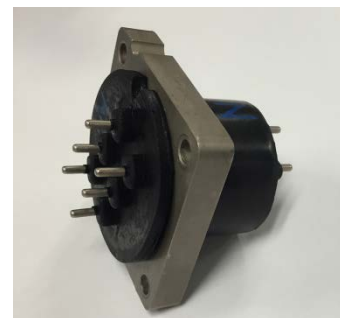
Figure 2 - Old Style Feedthrough
(6-Pin Feedthrough shown)
